**Soil Examination, Rainfall Simulation and Soil Runoff
and Infiltration Experiments following a flood event in
the Boscastle area**

Dr Nicholas Howden and Dr Lynda Deeks

National Soil Resources Institute

Draft Report to the Environment Agency

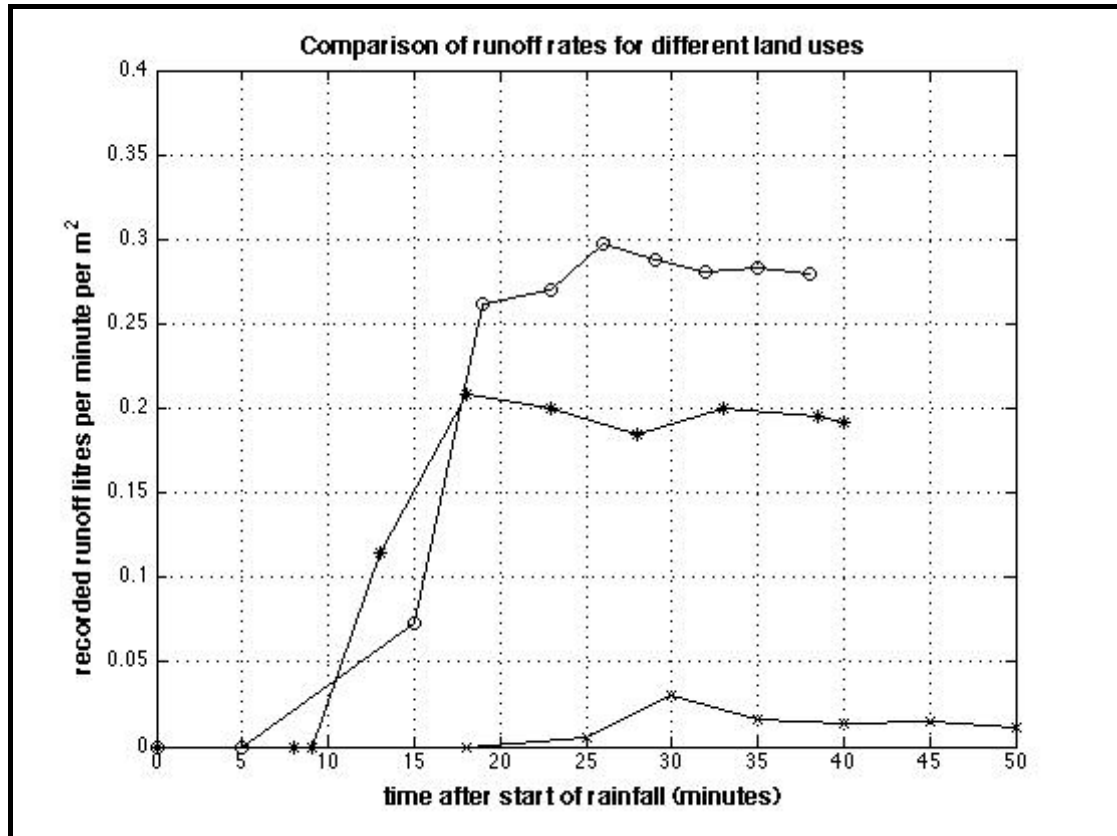
Figure 1: Plots showing runoff rate (litres per minute per square metre) for site 1 (steady runoff rate $\sim 0.275 \text{ l.min}^{-1}.\text{m}^{-2}$), site 2 (steady runoff rate $\sim 0.19 \text{ l.min}^{-1}.\text{m}^{-2}$) and site 3 (steady runoff rate $\sim 0.02 \text{ l.min}^{-1}.\text{m}^{-2}$), for an irrigation rate of 36mm per hour.

Note: Runoff rates have been adjusted to reflect small differences in rainfall rate during irrigation experiments and to express rates per unit area.

Figure 1 shows the response of each plot site over the period of irrigation. It is clear that the three soil structure types produce three different runoff rates, with the rate increasing from Site 3, to Site 2 to Site 1, from 0.02 to 0.29 l min⁻¹ m⁻².

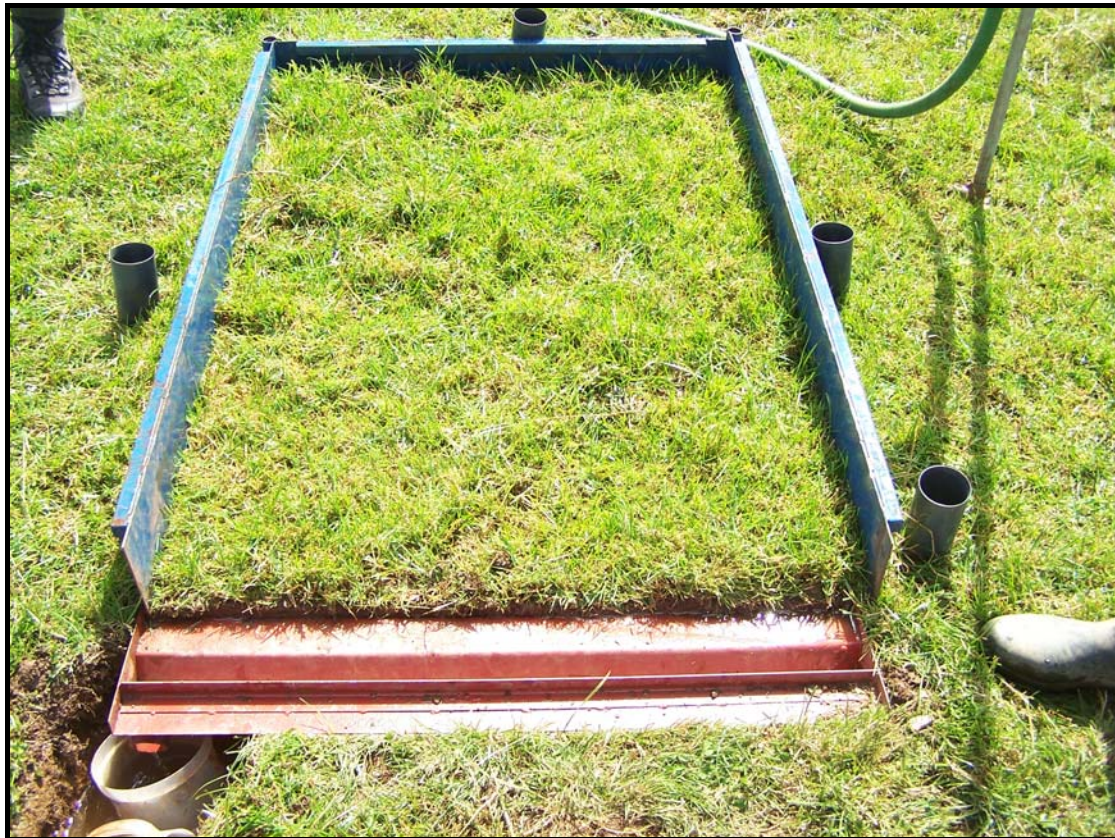
Figure 3: Rainfall simulation in progress. Photograph shows irrigation plot (blue) with rainfall cups measuring rainfall volume, tray collecting down-gradient surface runoff (red) and collection of runoff waters (bottom left).

- soil structure and bulk density survey;
- irrigation experiment:
 - initial characterisation of soil moisture around plot area and survey of plot characteristics (surface vegetation, slope etc.);
 - irrigation of marked plot at a rainfall intensity of 36 mm hr^{-1} (Figure 3);^[n3]
 - measurement of time to start of runoff, and then collection of surface runoff volume at appropriate time intervals;
 - after cessation of irrigation, measurement of soil moisture conditions and note of time to cessation of runoff;
- infiltration experiments using double-ring infiltrometers.

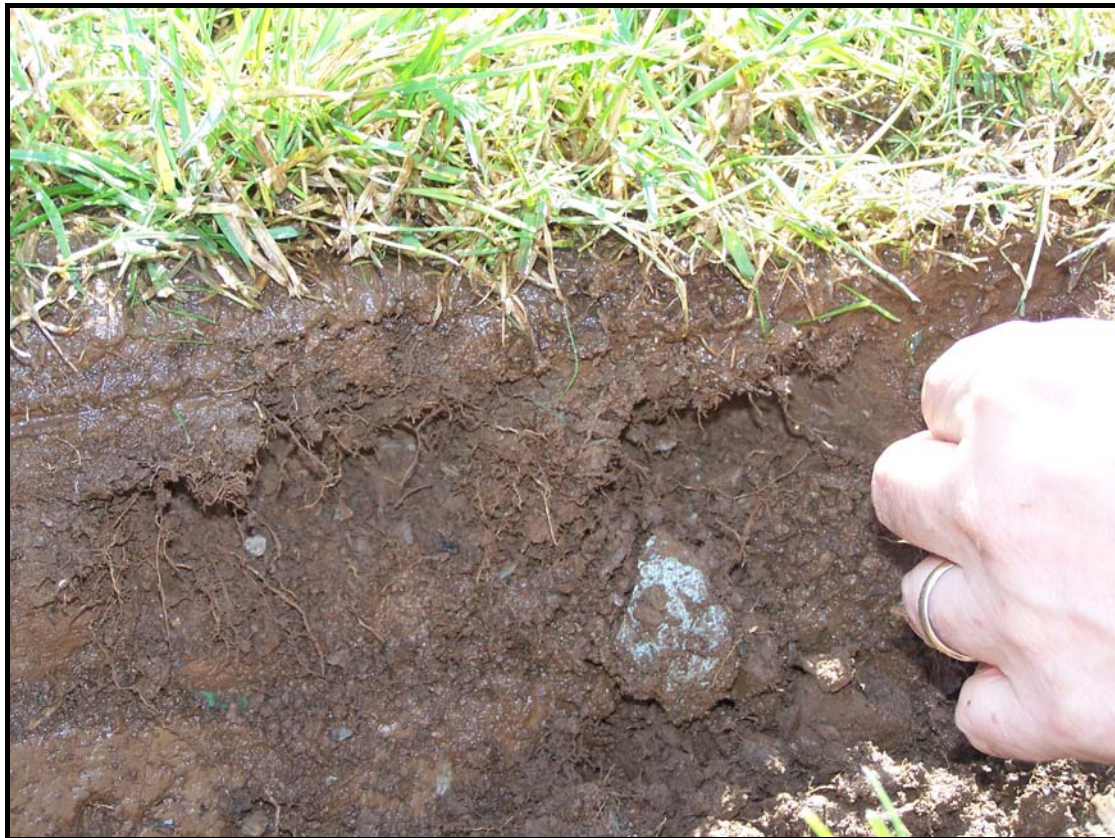
Figure 4: Photograph showing section of soil after irrigation. Notice that the top layer (~0 to 3 cm) is saturated, whilst the deeper soils remain dry.

During the irrigation experiments, it was noted at sites 1 and 2 that a significant volume of water was flowing down gradient through the root zone in the shallow subsurface (0 to 3 cm) in addition to surface runoff. The volume of this observed “throughflow” could not be measured, but appeared comparable to the volumes of surface runoff collected. Given observation of this flow mechanism, it is not unreasonable to suggest that 90% of the incident rainfall was moving down gradient in the irrigation plot during the simulation period.

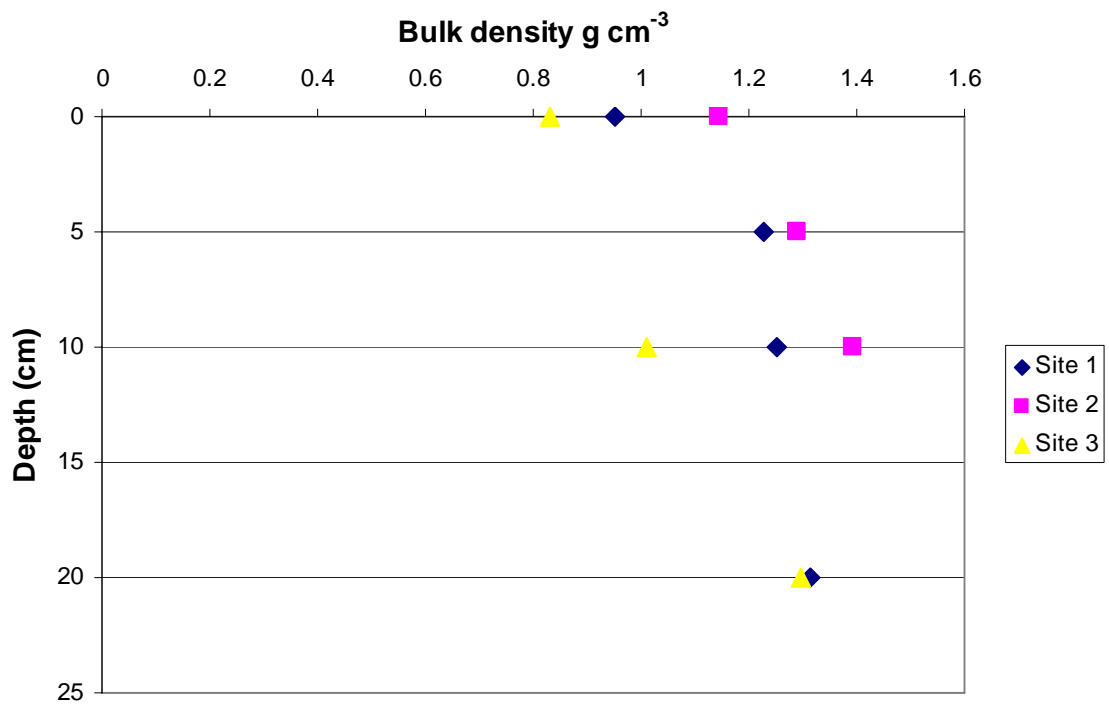
Figure 5 Variation of bulk density within the soil profile at the three Sites.

The mean bulk density recorded for the Denbigh series, under permanent pasture, is 1.15 g cm⁻³ for the 0 to 22 cm horizon (Findlay et al., 1984). Figure 5 shows how bulk density values varied in the three soil profiles. Sites 1 and 2 had higher than average (1.15 g cm⁻³) bulk density values, 1.16 g cm⁻³ and 1.28 g cm⁻³ (mean based on 0 – 22 cm profile), respectively. While Site 3 had a lower than average bulk density, 1.05 g cm⁻³ (mean based on 0 – 22 cm profile). Statistical comparison of the bulk density samples across the three sites

showed only Sites 2 and 3 to be significantly different (95% confidence limit) in the surface soil (0 – 2cm depth). The rate of change in bulk density with depth (0 – 2 compared to 10 - 12 cm) was greatest at Site 1 where bulk density increased by 32 %. At Sites 2 and 3 bulk density increased by 22 % with increase in depth. These changes in bulk density with depth equated to an 18, 16 and 10 % (Sites 1, 2 and 3, respectively) reduction in porosity over the 12 cm depth.
