# Silchester Roman Town

## The Baths 2018

Michael Fulford, Amanda Clarke, Emma Durham, Rob Fry  
Sara Machin, Nicholas Pankhurst & Dan Wheeler

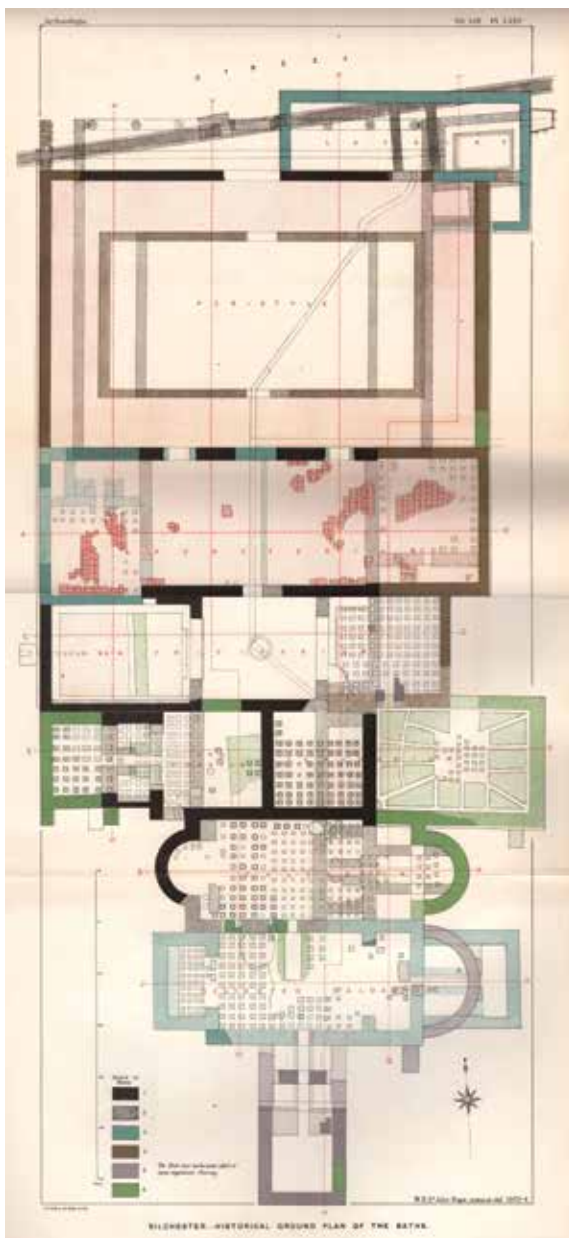
Fig. 4 Multiphase plan produced in 1905 (Hope and Fox, 1905)

With their focus on trying to understand the workings of the baths and how these changed relative to each other over time, there was little opportunity to discover the absolute dating of the various alterations. However a very important observation was that the first phase of the baths pre-dated the laying down of the east-west street of the town. The discovery of a Nero-stamped tile in the cess pit to the east of the latrine added further weight to the theory of an early date for the initial construction. At the same time and as a result of working within the building, few finds were made and so little was learned of daily life in the baths and how that changed over time. The aim of our excavation is to begin to address these two major gaps in our knowledge: chronology and daily life. At the same time, in re-exposing parts of the structure of the building it will be possible to learn more about the materials used in its construction and how these changed over time.

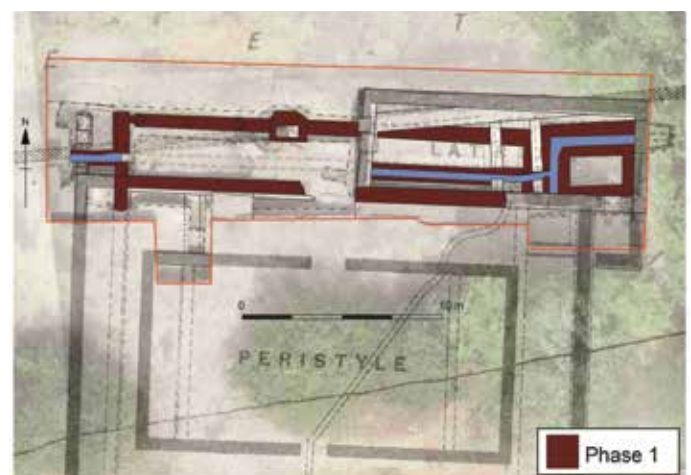
Fig. 5 The facade, Phase 1

Phase 1: the façade of the baths originally consisted of a wall of Greensand blocks, the surviving section topped with brick string courses. It was fronted by a colonnade supported by small columns of Painswick (Glos.) limestone resting on a brick-built stereobate. The wall survives to a height of 0.3m above its foundations, while the two surviving columns stand 0.33m and 0.4m high. The middle column, visible on the 1903-4 photography, had been removed. In the middle of the colonnade was the entrance

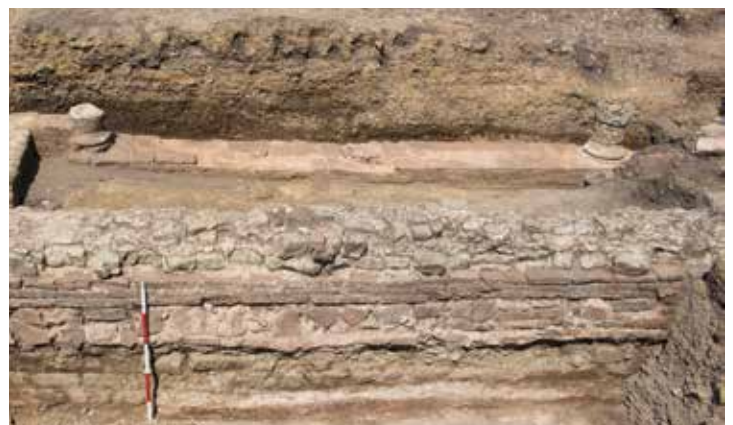
Fig.7 Looking north. The facade of the bathhouse fronted by the colonnaded stereobate

to the baths, flanked by brick piers c. 3.2m apart. A rectangular latrine block built of flint with brick coursing abutted its eastern end, its orientation slightly askew to that of the façade. This block was characterised by a water channel, 1.05m deep, which was traced around three sides, the fourth buried beneath a late extension of the façade. This was fed by a channel, lined by Greensand blocks, which ran immediately in front of and parallel with the front wall, entering the baths from the west through a brick arch.

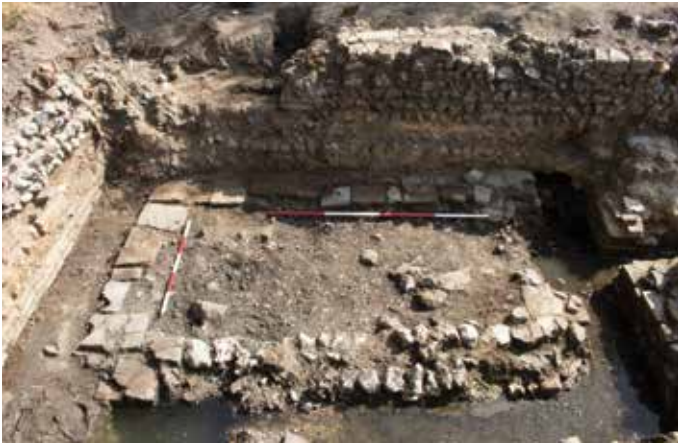
Fig.8 Water channel at the base of the early latrine, view to south

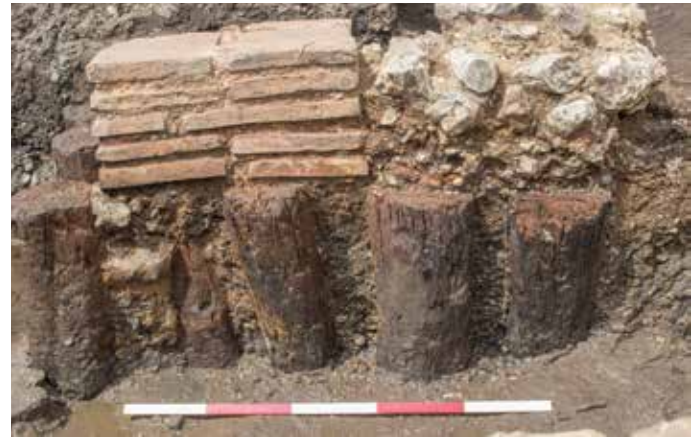
Fig.11 Corner of the facade extension supported upon alder piles, view to west

Phase 2: although we cannot be certain of their contemporaneity, extensions to the façade were added at both ends. To the west the wall was built out a further 2m, the new build simply butting on to the old, and, where the new external, west wall was built over the water channel, it was supported on piles of alder. An east-west foundation to support a colonnade running around the interior of the palaestra is in a similar type of build and probably belongs to this phase. At the eastern end the wall, now only of flint, was built out as far as the east end of the latrine and over its southern channel.

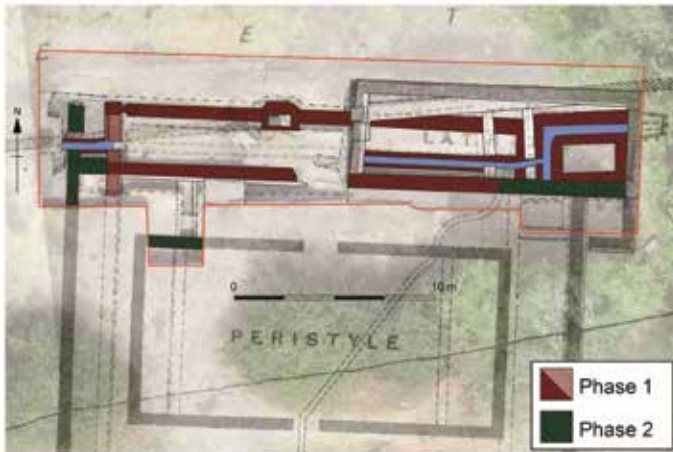
Fig.9 The facade, Phase 2

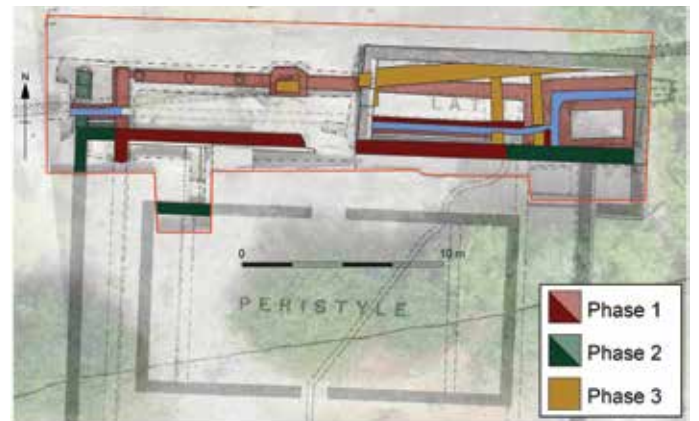
Fig.12 The facade, Phase 3

Phase 3: a further major modification took place which involved extending the latrine block westwards, the new north wall requiring the demolition of the colonnade to the east of the entrance. The line of the new build is askew to that of the north wall of the baths, its alignment apparently dictated by the course of the east-west street of the Flavian grid. It extended as far as the eastern pier of the entrance to the baths where it turned at right angles to create a new west wall of the block.

Though largely destroyed by later modifications, there are clear traces of an entrance, subsequently blocked, in the middle of the west wall. The extended latrine was thus trapezoidal in plan. Two cross walls sub-divide the internal space creating a possible lobby between the new extension and the original latrine. They appear to respect the water channel suggesting continuity of use. The two brick piers supporting the entrance to the baths were rebuilt on the same alignment, the western one on the reduced remains of its predecessor. The height of this suggests that ground levels had risen c. 0.7m, either as a response to the laying down of the street or to flooding. Contrary to the Antiquaries' interpretation, there is no evidence for the continuation of the new alignment across the rest of the frontage. Although the bases and the bottom of the shafts were buried by the rise in ground level there is no reason why the remaining columns and the western half of the portico could not have been left in situ. However, if the entrance had been rebuilt to give extra height, it is likely that the whole of the frontage was similarly raised which would have required columns of greater length.

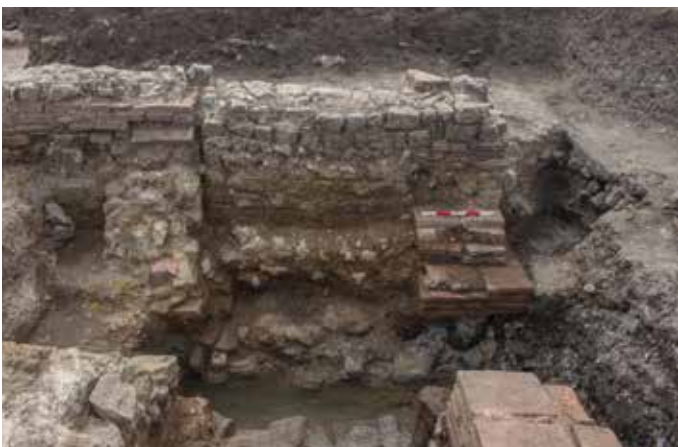
Fig.10 The extension to the western facade of the bathhouse, looking south

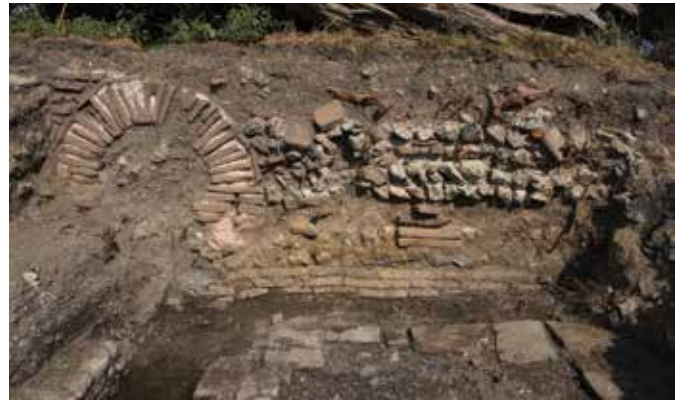
Fig.14 Eastern wall of the latrine with re-aligned drainage arch

Phase 4: The last major change to the frontage of the baths involved the rebuilding of the extended latrine as a rectangular structure and the construction of one, possibly two, new water channels. The north wall of the new structure now cut into the line of the street. It was made up of courses of massive blocks of naturally cemented gravel, flint and brick and overlaid the foundations of its predecessor returning at right angles to create a new west wall which was pierced by two brick-lined openings, the earlier doorway now blocked. At the east end a re-built wall included a brick archway to cover the outflow from the latrine. The positions of these openings to east and west

indicate that new and higher channels had to be created to ensure a continuous flow of water through the latrine.

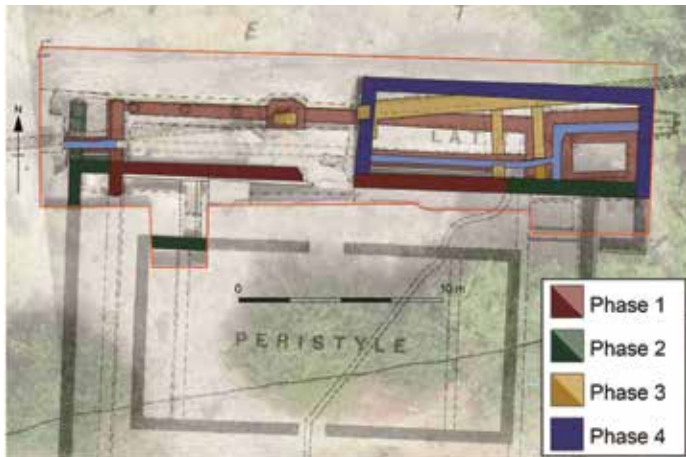
Fig.13 The facade, Phase 4

Any possible surviving traces of these new channels had been destroyed by the 1903-4 excavations. There is no evidence for the location of the new entrance to the latrine but it probably simply replaced its blocked predecessor at a higher level. No evidence was found to date this late re-building, but it is likely to have been in the later third or fourth century by which time the street had risen to within 0.2-0.3m of the present ground surface. This was the level down to which the Roman masonry was initially robbed in medieval times.

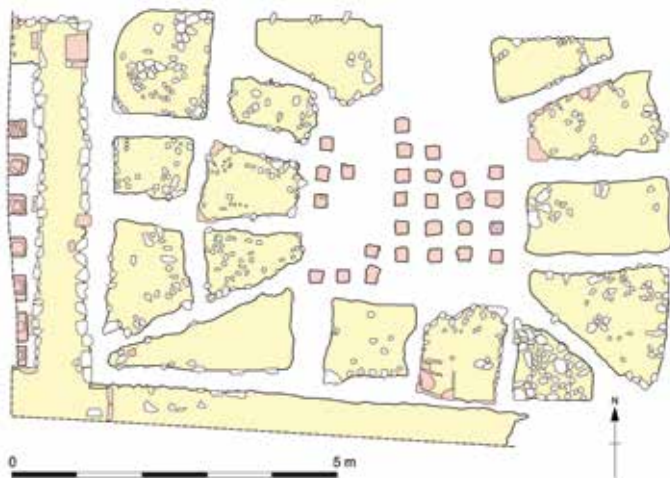
Fig.16 Hypocaust below the tepidarium

The excavation exposed the complete footprint of the foundations of the late Roman tepidarium which was built over an earlier structure on the eastern side of the baths. Covering an area of 72m<sup>2</sup> (9.75m by 7.45m) it was of mixed construction. The central area of the floor had been supported on brick pilae, but between this array and the outer walls the floor was supported on blocks of rubble masonry between which channels ran to convey the warm air to the (robbed out) flues running up the inside faces of the outer walls. A gap in the masonry on the north side indicated where the furnace had been located, but all traces of this had been robbed away. The width of the foundations on the western side of the pilae was such that they had to be bisected by a further channel aligned more or less north-south.

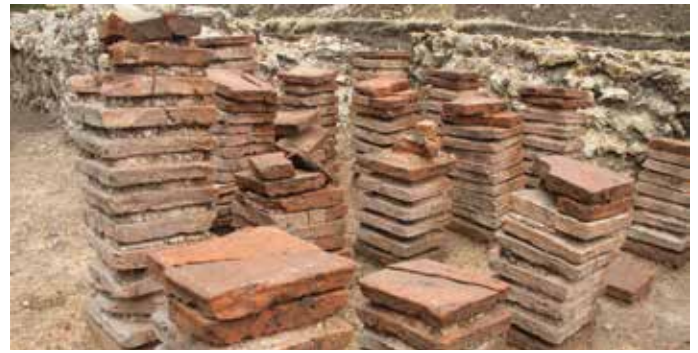
Fig.17 Pilae within the centre of the hypocaust

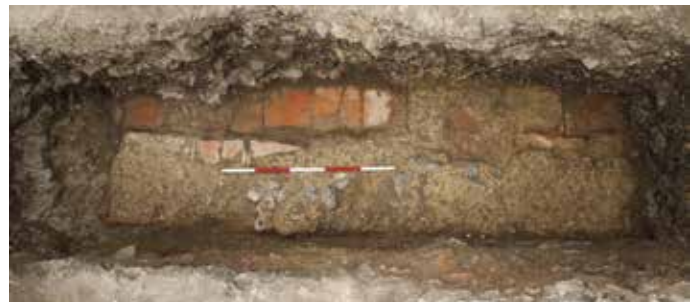
Fig.18 Potential early structure beneath the tepidarium

While the west wall had been robbed down to approximately the same level as the foundations of the tepidarium, the robbing of the south wall stepped down deeper into its foundations. This greater depth was carried on around the east and the north side where, at the base of the robbing, were the remains of a tiled foundation of an earlier structure. The greater depth to which the three outer walls of the tepidarium had been robbed suggests a different and later phase of robbing to that which had reduced the masonry of the east wall of the baths to which the tepidarium had been attached.

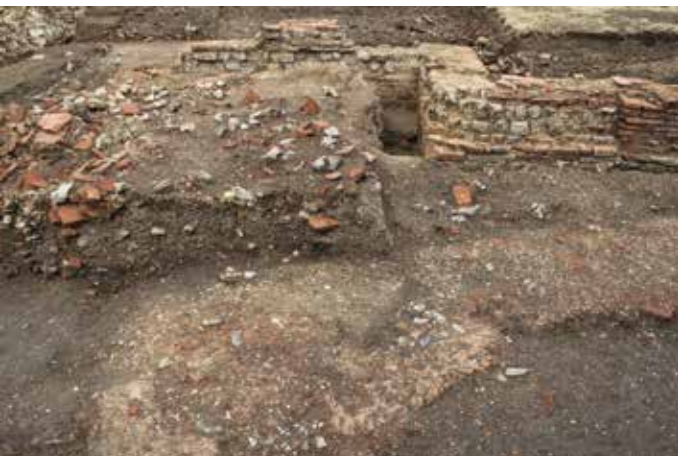
Fig.21 Trench 2, the eastern wall of the baths with outer surfaces covered by rubble from medieval robbing (left)

To the north of the tepidarium the east wall of the baths formed the west edge of the trench which was designed to explore the deposits which had accumulated during the lifetime of the baths. These included the fill of the trench of 1903-4 which had defined the outer edge of the east wall as well as contexts which related to the robbing of the structure in the medieval period. This process had resulted in the discard of large quantities of broken CBM (ceramic building material); the stone removed elsewhere. Although a further large deposit of broken CBM remains to be excavated in 2019, the uppermost levels of Roman occupation have been reached across the rest of this part of the trench.

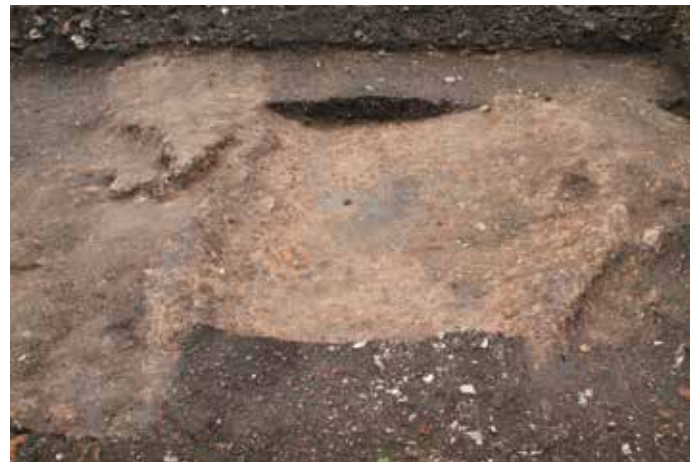
Fig.23 Trench 3, late Roman crushed tile surface slumping into the underlying Iron Age ditch

The area excavated to the east of the tepidarium ran down slope towards the stream. It extended across where the geophysics had indicated the course of what might be the Late Iron Age Inner Earthwork. Clear evidence of the trial trenching of 1903-4, running north-east/south-west across the grain of the insula, was recovered. There were also traces of the clay-filled beam slots of a medieval timber building towards the east end of the trench. Excavation and coring confirmed the ditch. By the end of the season excavation had begun on the latest Roman fills which had subsided into its fill. These were characterised by large quantities of fragmented *opus signinum*.

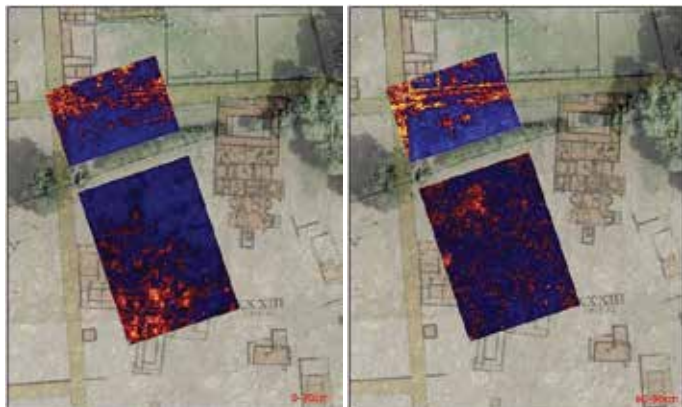
Fig.34 . Depth Slices (30cm & 90cm) showing the Bathhouse Area GPR Survey

A rectangular area (114m by 50m, 0.5ha) was surveyed either side of the extant field boundary to the west of the bath-house excavation (Fig 34). The aim of this survey was to investigate further the potential existence of conduits or leats which might have supplied water to the bathhouse.

The survey within this area was successfully able to identify known archaeological features which verified the Antiquaries plan and added detail to the previous geophysical survey of the area (Creighton with Fry 2016). The east-west street, and associated roadside buildings and walls are especially prominent. It is notable that the area within the same Insula, but to the west of the bathhouse, appears to have been relatively open, with no major structures recorded here in any previous investigation.

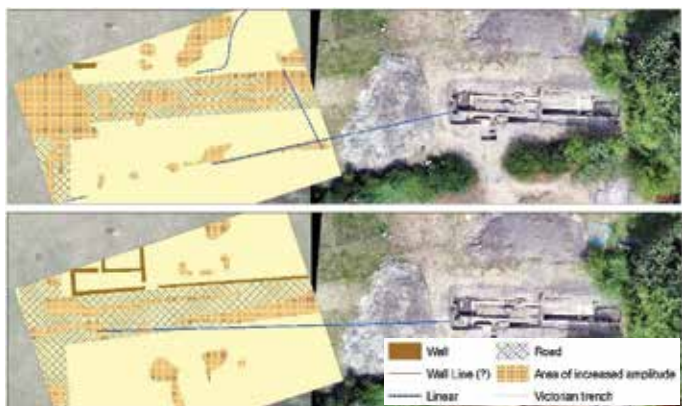
Fig.35 . Extracts from the GPR Interpretation (30cm and 90cm depth slices) highlighting the potential conduits extending towards the bathhouse

At two separate depths within this area however, faint linear anomalies (highlighted in blue, Fig 35) can be seen extending towards the excavated leat discovered within Trench 1 and may relate to such water feeds.

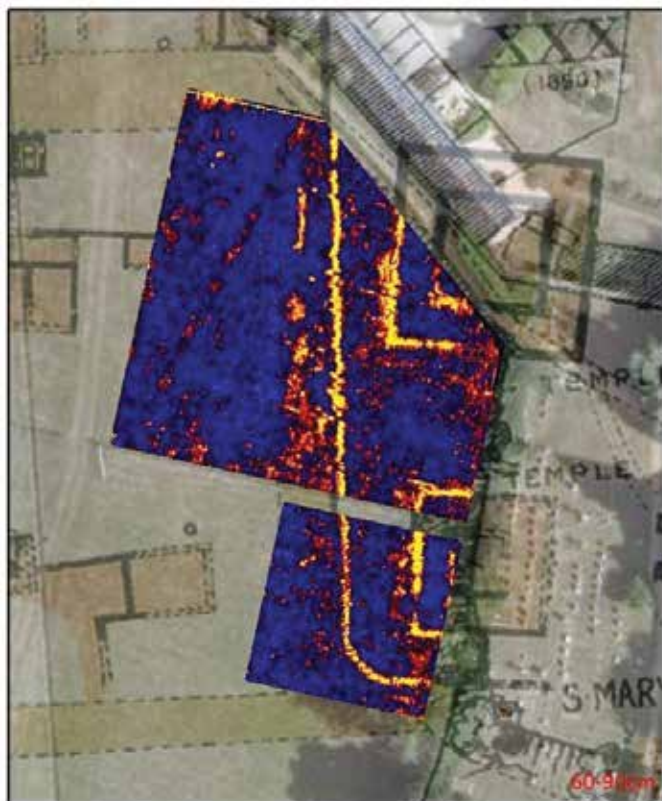
Fig.36 Depth slice (90cm) showing the western edge of the southern temples, and detail of the temenos wall

The GPR survey within the paddocks to the west of the extant graveyard covered an area of 62m by 40m (0.18ha). The intention of the survey was to complete a series of previously undertaken GPR surveys (Thornley 2014, Fry 2016) which focussed on the course of the temenos wall surrounding three Romano-Celtic Temples now known to exist here. As Fig 36 shows, the two southern temples appear prominently within the data, indicating they are relatively well preserved. The temenos wall, extending north-south, and curving 90 degrees at its southern extent, fits almost exactly to the Antiquaries plan, validating it and linking up with the previous GPR surveys.
